The Locomotive

THE HARTFORD STEAM BOILER
INSPECTION AND INSURANCE CO.

VOL. XXXVIII

HARTFORD, CONN.
1930-1931

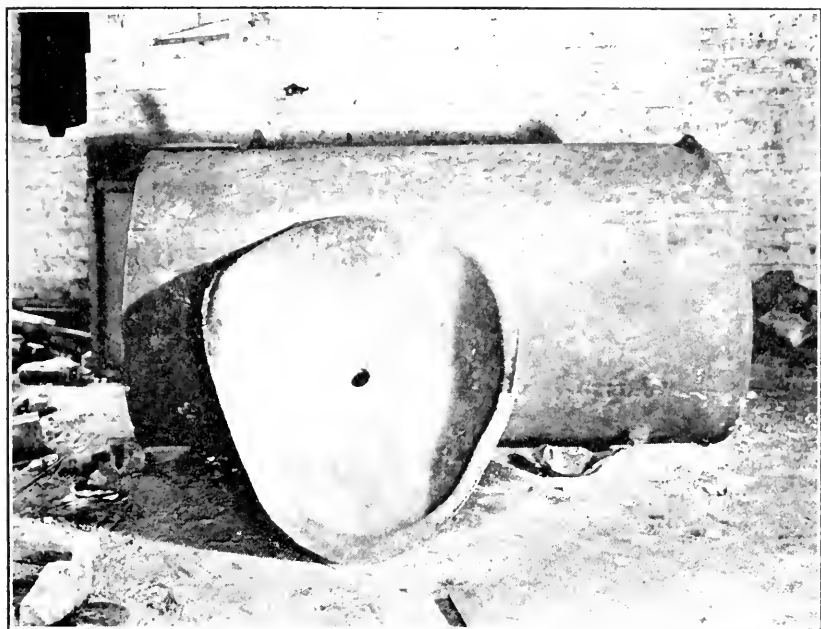
Figure 2

The tank was a part of the hot water supply system of the McCrory five-and-ten-cent store and was located in a part of the basement that extended out under the sidewalk. As a consequence dozens of persons were above it when it let go. Many of the victims fell into the hole in the sidewalk where they were scalded and crushed as the tank, its upward flight arrested by a heavy I-beam supporting the overhanging

store-front, fell back through the opening on top of them. Emergency squads of firemen and police turned to the work of rescuing the injured and freeing the bodies of the dead, while ambulances and doctors from all hospitals in the city waited to carry the victims away. A large motor derrick was pressed into service to aid in shifting the heavier pieces of wreckage. Much of the wreckage had been cleared away by the time the photograph shown in Figure 1 was taken.

Those who were near enough to witness the tragedy without themselves being injured said that simultaneously with the terrific blast the sidewalk shot skyward, the store-front collapsed, and scores of persons were mowed down by pieces of masonry and other debris that swept the street like a burst of shrapnel. One large chunk of concrete struck and killed instantly a woman who was on the side of the street farthest from the explosion. Hospital attendants expressed the opinion that many of the more seriously injured were hurt in this manner. In several instances the explosion ripped the clothing from its victims.

The exploded vessel was a vertical tank six feet long, 37" in diameter, and welded throughout. Its shell was of 3/16" steel plate and both heads were of quarter-inch material. It appears that the bottom head had a flange or skirt and was fitted inside the shell so that it had a "minus" dish and that excessive pressure turned this head inside out (see Figure 2) and tore it loose from the shell at the welded joint. The top head was of somewhat different construction. It was without a flange and was installed so that it bumped outwardly, resembling a large, shallow saucer with its rim welded to the end of the shell plate.

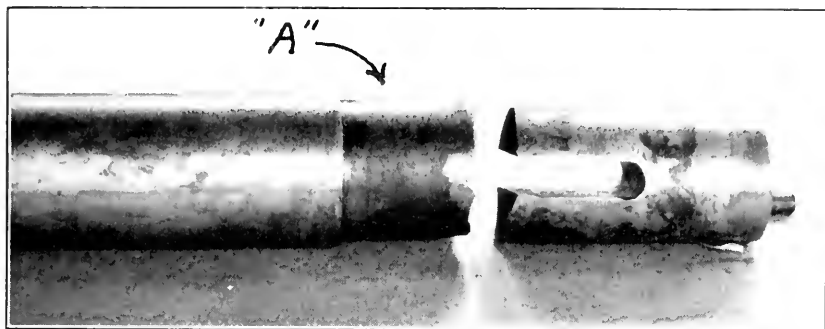
Figure 1

A case in point, where a dismantled inspection would have been very useful, is illustrated by the accompanying photographs showing the result of and the apparent reason for a progressive failure in a piston rod. Figures 1 and 2 show respectively the broken piston rod and the endwise views of the fracture. The latter show clearly the characteristics of a crack which progressed slowly until only the small, dark area at the left of Figure 2-a and the corresponding dark area at the right of Figure 2-b remained unbroken.

It is evident that the rod had been flexing a small amount, and that this first caused a slight surface overstress. In time the surface crack penetrated the rod, thus reducing the area of sound metal to a point where there was not enough left to withstand the normal load stress. From an examination after the accident it was apparent that the fit of the rod in the crosshead left much to be desired, the rod being tight only at its extreme end. This condition can be seen in Figure 1, the bright area near the end showing where the rod fitted tightly, and the dark area "A" near the shoulder giving evidence that there had not been a proper fit at that point. Of course, this was what allowed the flexing and the subsequent failure.

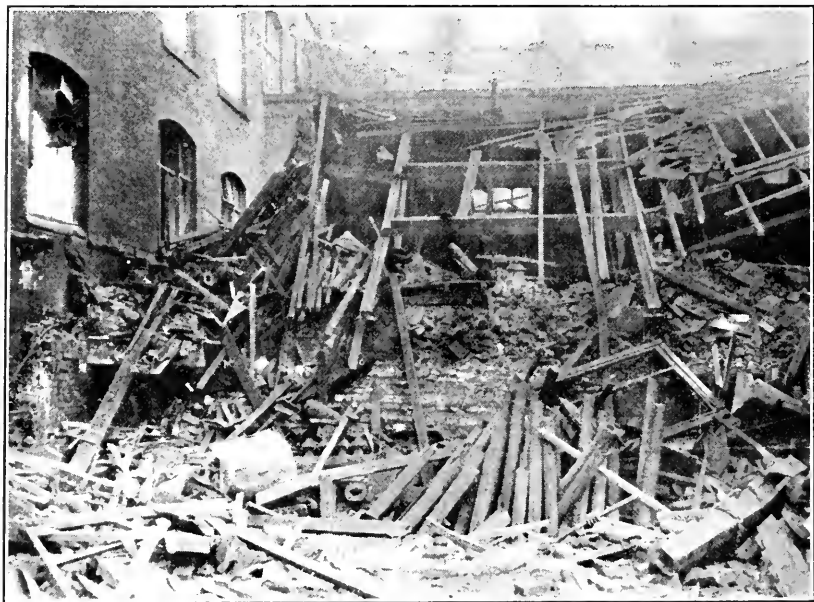
FAULTY manipulation of the dampers and feed line valves on an economizer of the ordinary cast iron type recently caused a very serious explosion that not only destroyed the apparatus itself but wrecked the building housing it. The accompanying illustration is a photograph of the wreckage.

and there was no chance for a circulation of water through it, the hot flue gases started to generate steam which overheated the metal and probably caused serious expansion stresses at the joints between the tubes and the upper header. The explosion occurred about half an hour after the fires were stirred up. It is suspected that even though the gases were by-passed around the economizer during the night, there may have been enough leakage past the damper to keep the tubes fairly hot, so that steam was quick in forming after the full supply of flue gas was shunted through the apparatus.

An examination of the fractured tubes showed that many of them had been affected internally by graphitic deterioration. Wall thickness

was generally well maintained but at some points the greater part of the cast iron seemed to have been converted into a graphitic structure. At places this graphite had broken away from the tubes, leaving a very much reduced thickness of good cast iron. Undoubtedly, this change in the nature of the material had taken place over a long period, for the economizer was twenty-five years old.

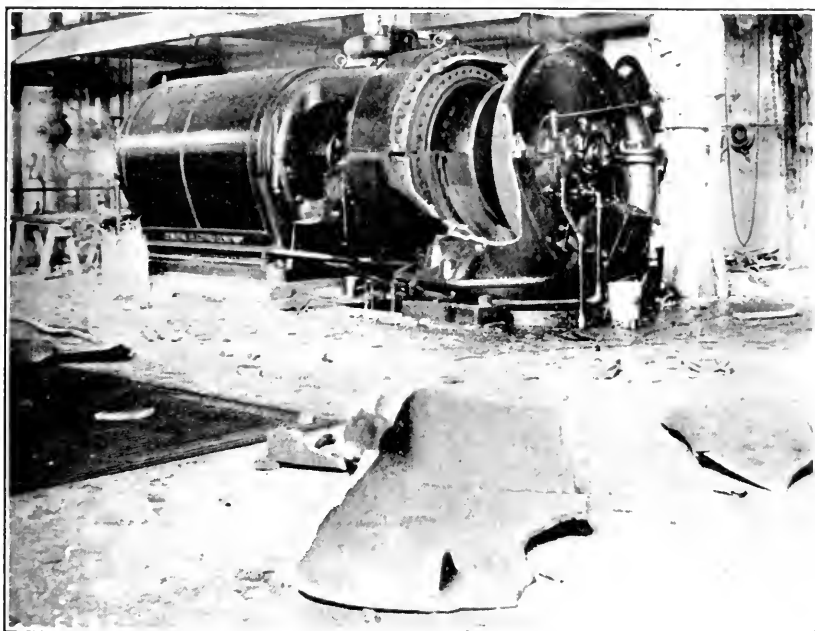
Figure 1

A 3,000 kw. turbo-generator at the Akron, Ohio, plant of The Quaker Oats Company exploded without warning on September 20th, 1929, when a third-stage rotor disc burst while the machine was running at normal speed. (See Figure 1.) The watch engineer had a narrow escape from death or serious injury, for only two or

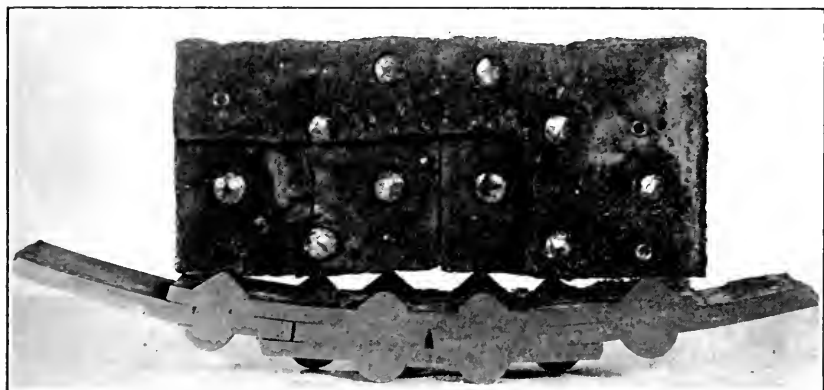
Figure 1

WHILE examining a Scotch Marine boiler recently, an inspector noticed slight leaks at a girth seam and around the manhole reinforcement ring. On questioning attendants, he found that they were aware of the leaks and had made an unsuccessful attempt to stop them by caulking. The condition was such as might indicate cracks in the plate, so the inspector had the engineer remove enough

of the lagging to permit examination of the longitudinal seam. There he found four broken rivets and two others that appeared to be cracked.

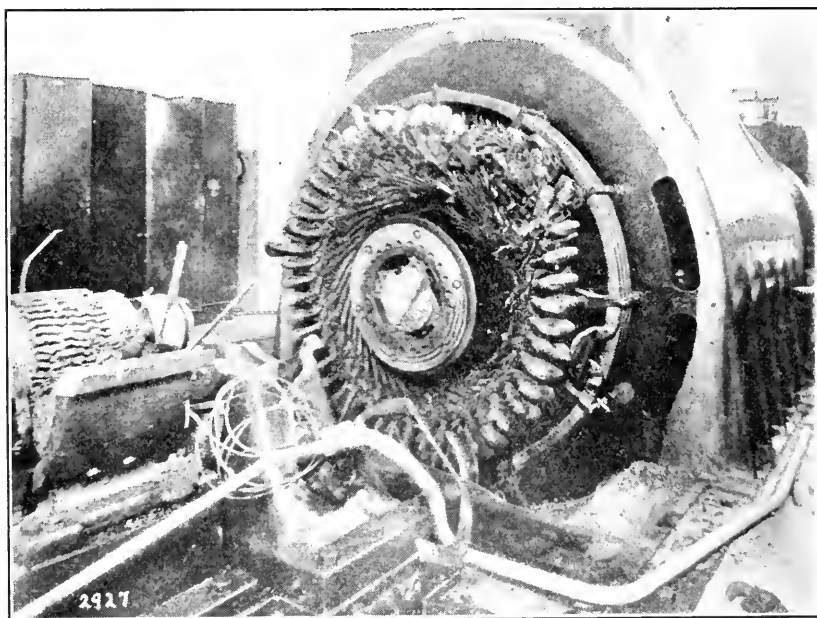
Figure 1

A VERY disastrous turbo-generator explosion occurred on October 7th, 1929, at a power plant in Texas. A 6,000-kw. machine was so badly damaged that only the turbine casing and the generator frame could be salvaged. The owners were reimbursed to the extent of \$25,000, the limit at which the unit was insured, but the total loss was over \$80,000.

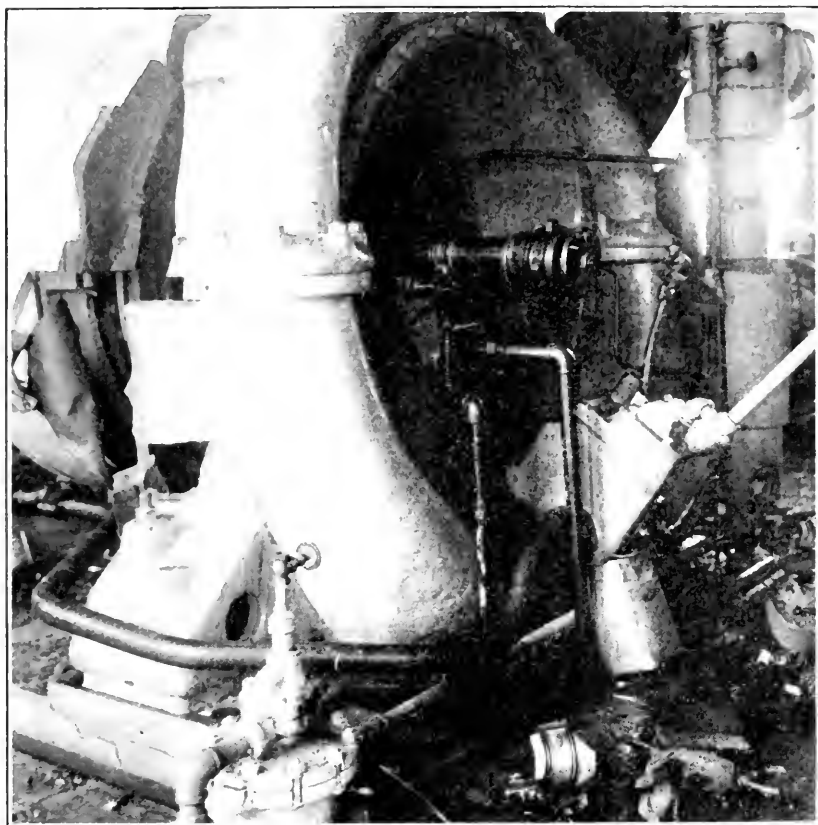
Figure 2

sudden drop in the a. c. voltage, accompanied by "hunting" on the part of the governor, the operator cut out the automatic voltage control and sought to correct matters by hand regulation. While he was thus engaged, the machine lost its load and he tripped the emergency governor to shut it down. At that instant the explosion occurred.

The turbine shaft and generator shaft were heavy, one-piece forg-

ings, supported on three bearings and fastened together by a rigid coupling. A fourth bearing supported the end of the exciter shaft which was joined to the outboard end of the generator shaft by means of a flexible coupling.

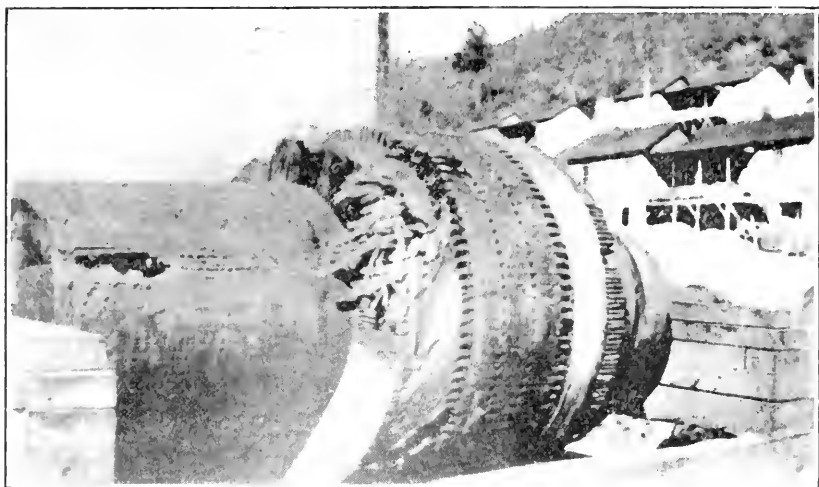
THE accompanying picture shows, in a fair degree, the extent of the damage caused by a breakdown of the armature of a 200-kw. rotary converter operating at 275 volts, 1,200 r.p.m., 3 phase, 60 cycles. It was the practice of this assured to attempt to blow out his rotary converters by means of a "hand bellows" instead of providing a source of compressed air for this purpose. Due to a lack of proper

air pressure as a result of the use of the hand bellows in cleaning, an appreciable amount of carbon and copper dust from the commutator brushes and collector ring brushes accumulated in the armature winding, or perhaps in the equalizers of the armature, and when a ground developed on the winding, the armature failed in many places as shown in the picture.

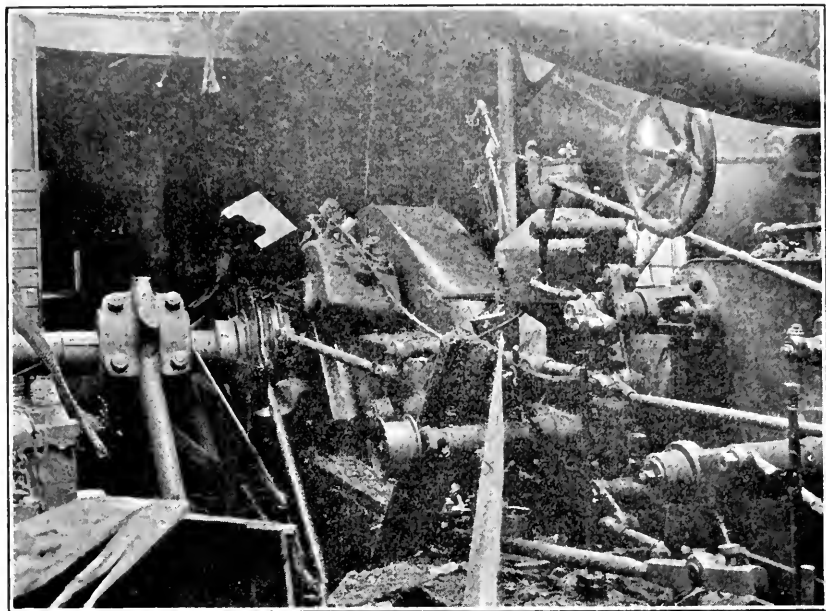
This rotary converter supplies direct current power for a coal mine and the service is naturally quite severe. In addition there are times when electrical apparatus in that class of service is not given the care and attention that is necessary for normal life. In many cases an excessive quantity of "make-up" oil is poured into the bearings and the overflow is drawn into the winding. This oil forms a wonderful binder for coal dust from the mine, as well as carbon and brass dust from the commutator and the collector rings. Such a mixture is of course highly inflammable and it is a good conductor. Therefore, when a failure that might ordinarily be of a minor nature occurs, the resultant damage is great. Repairs in this particular case cost approximately \$1,600.00 and the machine was out of service for several weeks.

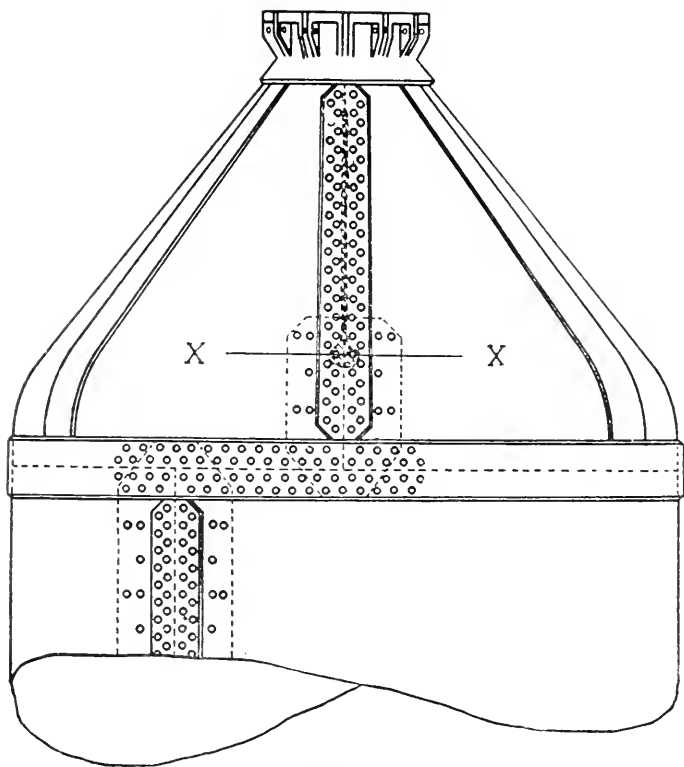
Figure 1

just opposite the center line of the butt strap joint, and at the height indicated by the line XX. Figure 2 shows the cross section at this point. The liquor penetrated the digester brick lining and the cement backing until it reached the inner butt strap. At this point some deterioration, although not extensive in area, occurred, but involved in this deteriora-

tion was one of the rivets. The liquor following through this rivet and eating out the metal between the rivet hole and the edge of the shell plate at the joint, soon reached the open space between the shell plates at the joint. Here of course there was a channel possibly $\frac{1}{8}$ " by $1\frac{1}{8}$ " running the whole length of the joint and covered on both sides by the butt strap. However, this gave the liquor opportunity to corrode the outer strap, and when discovered a channel had been cut in the outer strap so that for a considerable distance it was only $\frac{1}{8}$ " in thickness.

girth seam so that the cone top was still supported by the girth seam. However, had this leak occurred at one of the butt straps in the lining in the cylindrical shell of the digester, the corrosive action might easily have extended over the entire length of the course with resulting weakening of the structure which would, without doubt, have resulted in an explosion.

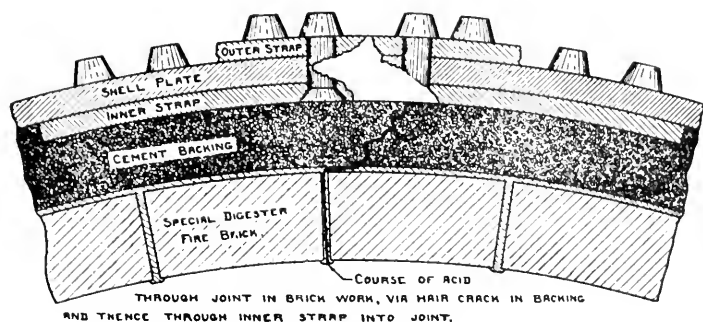
Figure 2

Approximate section at X-X showing the manner in which corrosion took place.

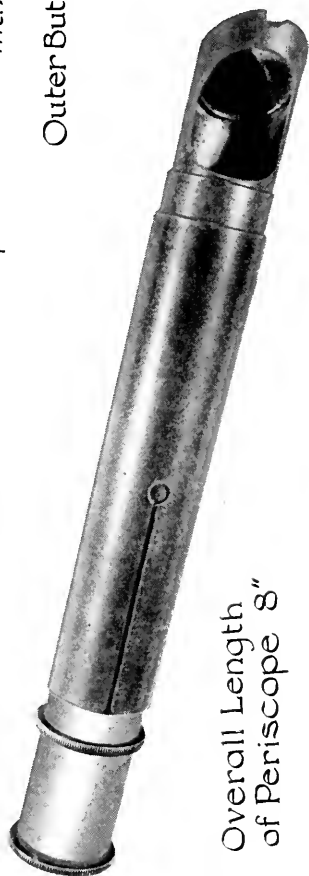
Rivet Hole is illuminated by a beam from a flashlight held by an assistant on the side of the shell opposite the Inspector. By revolving the periscope and moving it in an endwise direction Inspector is able to examine entire surface of hole magnified 22 times.

Figure 1 shows the Hartford Rivet Hole Periscope, designed in 1928 by Assistant Chief Engineer Morrison especially for the purpose of searching for fine rivet hole cracks. This instrument has proven of utmost value in many occasions and is one of the means whereby early discovery of caustic action has been made possible. Cracks so small that they are entirely invisible to the naked eye are magnified twenty-two times by the reflecting mirror and lens, and no matter how deep the hole the instrument permits a minute examination of every portion of the wall. Besides this instrument, two others of somewhat different principle have been designed by the Company's technical department, and are proving of great aid to inspectors.

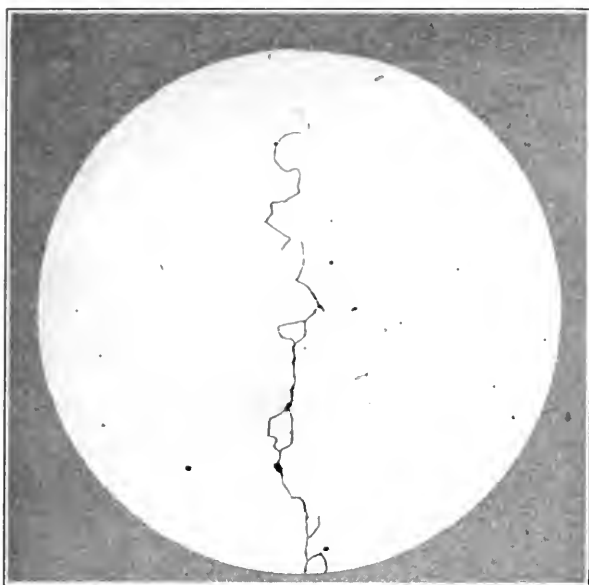
Figure 2

An actual photograph of an "embrittlement" crack magnified to 100 diameters. This gives an idea of the microscopic dimensions of the fissures which the inspectors find with the aid of the periscope.

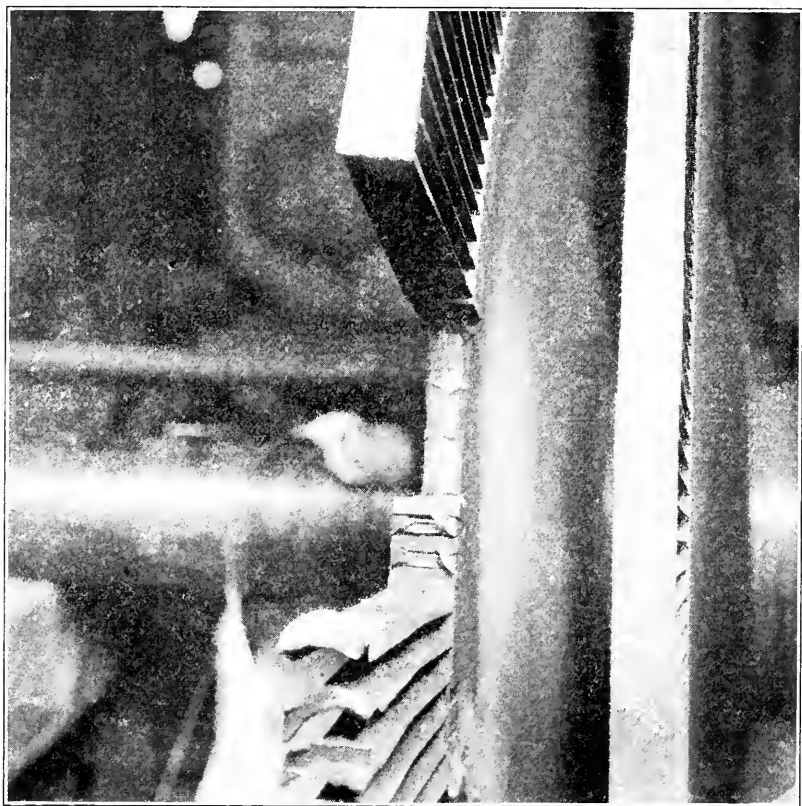
Figure 4

The periscope in use by an inspector on the mud drum of a water tube boiler. Muriatic acid and fine emery cloth are used to polish the hole so that, to the naked eye, its surface appears bright and smooth.

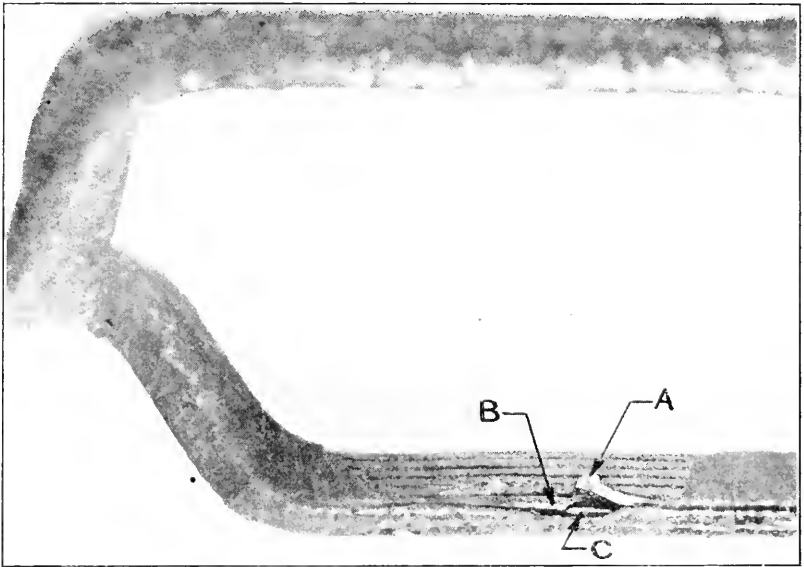
One end of this conductor was forced out of position approximately one eighth of an inch as shown at "A" in Figure 1 while the other end of the conductor was only slightly disturbed as shown at point "B." The adjacent parallel conductor was undamaged as shown at "C."

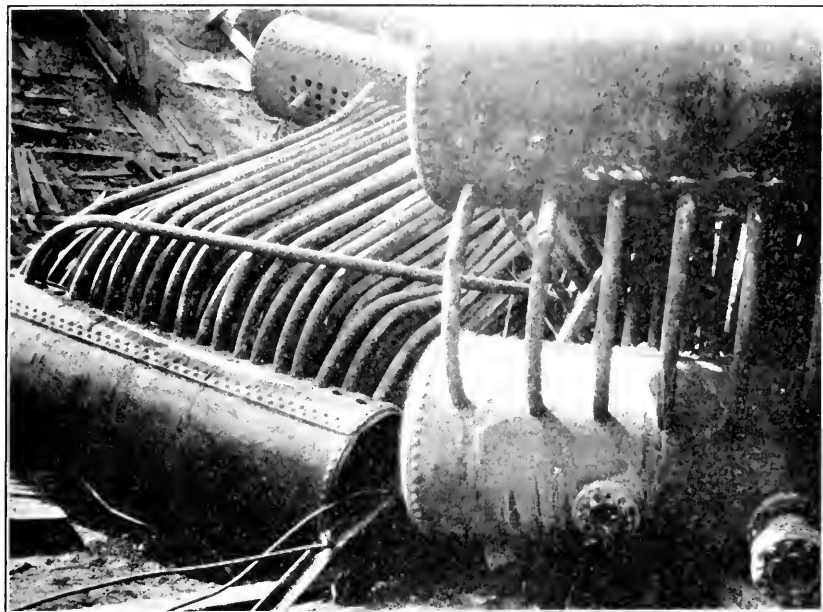
Figure 2

The style of setting used for the smaller boilers was such that the plain heads of their mud-drums were enclosed in masonry and were inaccessible for exterior inspection. An accumulation of soot, ashes, and moisture in the narrow space between the setting and the head that failed had led to considerable external corrosion, and the weak-

ening thus caused was further aggravated by the obsolete, somewhat flattened design of the head in which breathing action would produce flexing at the sharp turn of the flange.

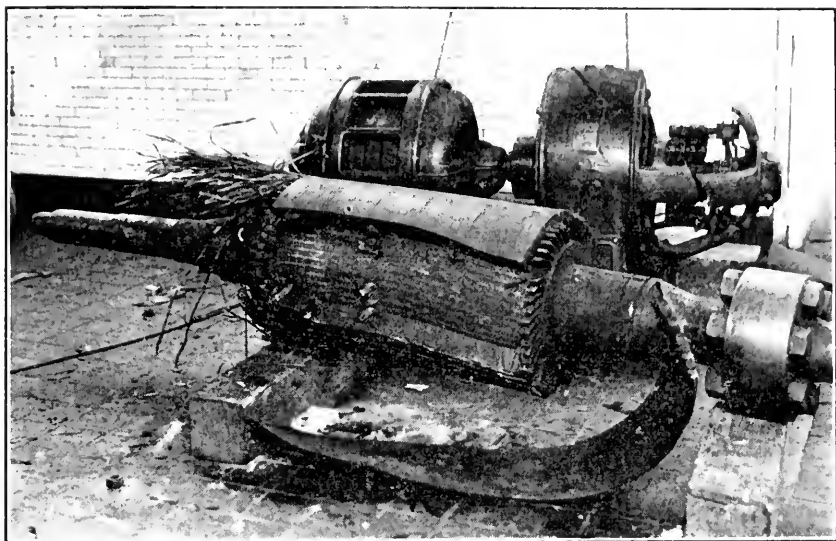
At the plant of one of our assured the heavy alloy steel shroud rings supporting the end turns of the field winding gave way because of overspeed. One of the rings wedged between the rotor and stator so tightly that it broke the frame of the stator and caused it to rotate with the rotor, thereby wrecking the entire unit. The illustration shows a failure of this type.

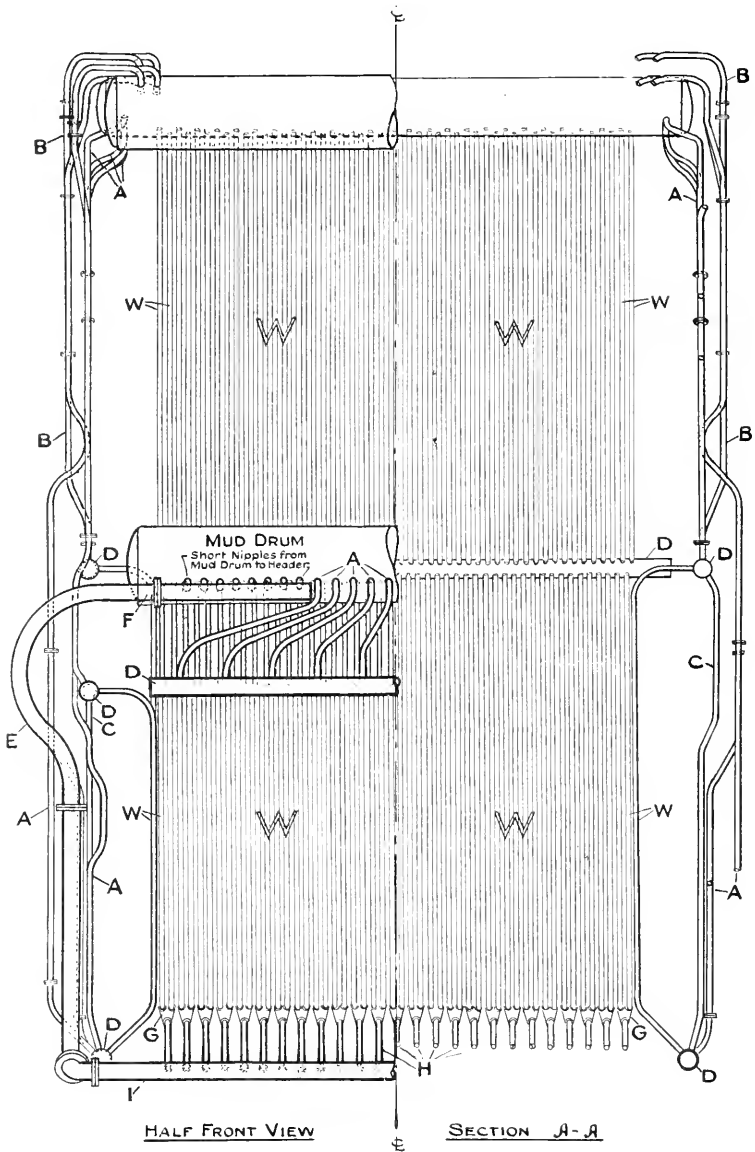
Two large vertical, bent-tube-type boilers, installed about a year apart, had almost completely water-wall cooled furnaces. They were fired with powdered coal through eight horizontal burners arranged in two rows in the lower part of the front of each furnace. The burners had vanes which directed the issuing mixture sidewardly, the upper row to the right and the lower row to the left. Trouble was experienced in the older boiler by the failure, near their upper ends, of a couple of tubes of the left sidewall. As the furnace was about 25 feet high it was difficult to make a close examination until repairs to some superheater tubes made necessary the construction of a scaffold inside the furnace. A careful scanning of the side wall tubes showed there was a well defined but restricted area near the top in which overheating was quite apparent and where further failures were probable.

Preparations were at once made to replace those tubes. A minute examination of all the rest of the furnace walls and particularly the corresponding area on the opposite side showed all tubes to be in first class condition. The whole layout was perfectly symmetrical, so the one-sided trouble could not be assigned to deficient circulating characteristics. Critical observations of the flame action and combustion processes in the companion boiler seemed to indicate that the swirl of burning fuel from the bottom burners in its upward trend impinged intimately against the left sidewall tubes near the top. The corresponding swirl from the top burners just missed the top of the right sidewall tubes, above which there are the boiler tubes and a relatively small area of fire brick wall. As this theory of the effect of the swirling gases seemed to be the right answer, it was suggested that the vanes of the left hand end burner of the top row be altered and thus sufficiently change the flame direction to prevent impingement.

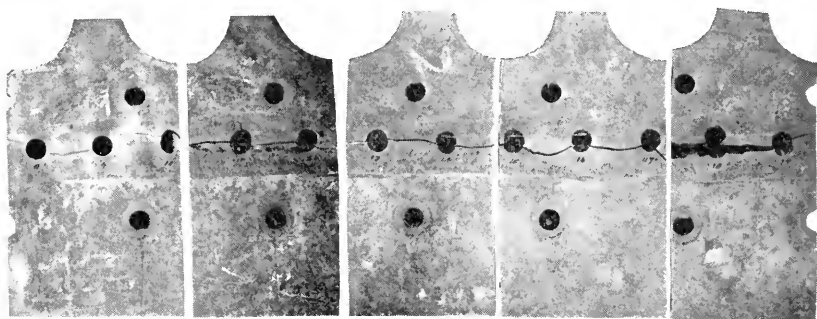
Figure 1

At one plant in the western part of New York state the drums of seven boilers of the Babcock and Wilcox cross-drum type were affected

so extensively that their continued use would have been dangerous. At another plant, located in Utah, six out of a battery of 14 boilers of the Stirling type had to be taken out of service.

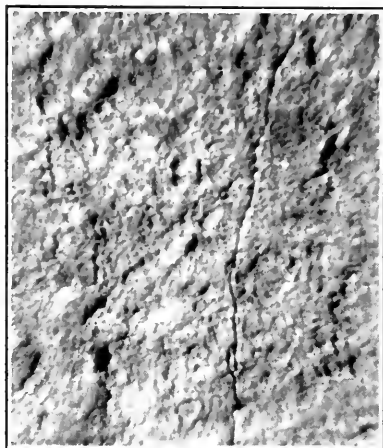
Figure 2

One of the peculiarities of the case was that no signs of leakage could be seen at rivet heads or seams of any of the boilers in which rivets had been broken. However, after driving out the shanks of some of the broken rivets and polishing the walls of the holes with emery cloth, the inspector was not long in detecting several fine, hair-line cracks. Although invisible to the naked eye these cracks were clearly apparent under a magnifying glass.

While examining boiler No. 6, in which the cracks seemed to be in the first stage of development, the inspector was told of the previous finding of broken rivets in boilers Nos. 8, 7, and 1, so he was more or less prepared for what was disclosed when the butt-strap of boiler No. 1 was removed and the shell plate was found cracked for a distance of 42 inches along a line of rivet holes. Pieces of shell plate taken from this seam are shown in Figure 1. None of the other boilers were affected quite as badly as this one but all were cracked to such an extent that it was deemed best to order new drums.

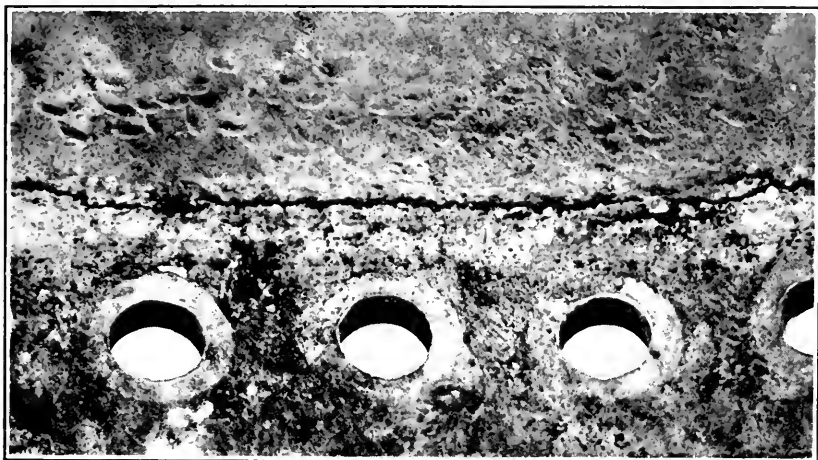
Figure 2

portion of the head containing the crack is shown in Figure 2. Similar cracks were found in the corresponding heads of three other boilers. It is not difficult to imagine what might have happened had these cracks not been discovered.

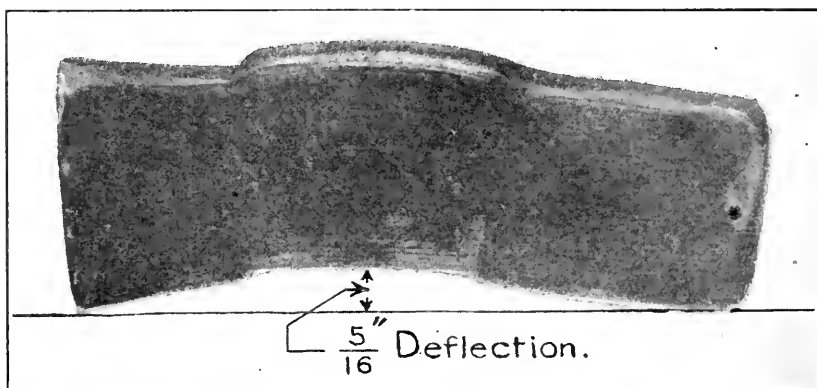
Figure 1

THE crosshead key shown below was bent due to water entering the low-pressure cylinder of a compound Corliss engine. The circumstances under which this occurred some years ago were rather unusual in that there was practically no other damage to the engine. As a rule when engine breakdowns occur from excessive water entering the cylinders the damage is quite extensive and often the engine is a complete wreck.

one evening it was noted by the operator that the last revolution of the belt wheel ended with a rather severe shock as if there were a sudden obstruction. He examined the engine and wheel for any possible damage but could not readily find anything wrong.

Had the engine had more speed when this water entered, the cylinder head would undoubtedly have been pushed out and other incidental damage to the cylinder would have occurred as is commonly the case under such circumstances.

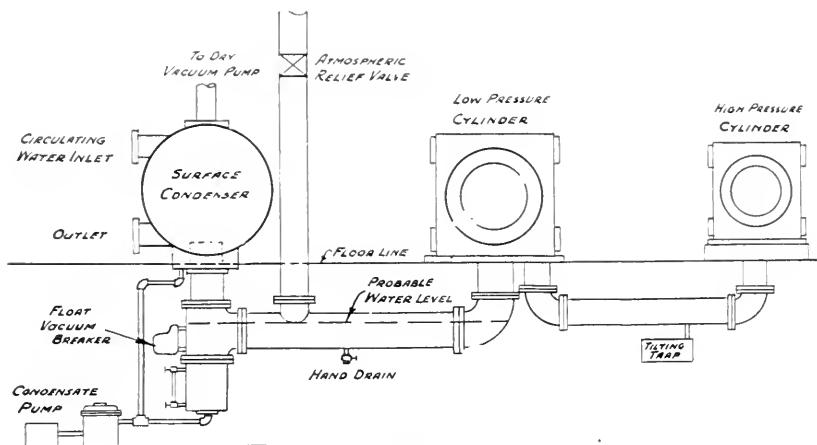
Figure 2

It was not immediately clear where the water could have come from but a careful check up of all the possibilities of the exhaust connections (shown in Fig. 2) made it evident that apparently water had accumulated in the exhaust pipe so that it may have reached a level as indicated by the dotted line. The float vacuum breaker must have stuck

closed so that it did not open earlier while the engine was still under load. The vacuum breaker apparently released itself or may have been opened by hand during the last few strokes of the engine. This allowed the water in the exhaust pipe to be driven into the low-pressure cylinder.

The condensate pump which was also float operated, apparently had run too slowly or may have been stuck for some time prior to the shutting down of the engine.

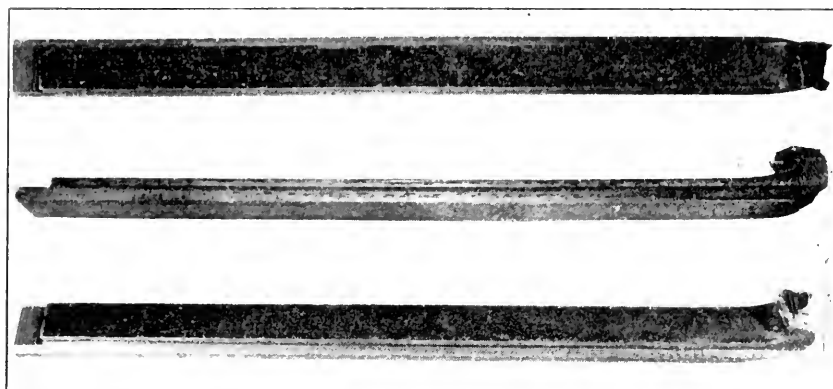
Figure 1

FROM time to time serious electrical troubles of an unusual nature, arise that may, in most cases, be foreseen and avoided by good engineering in operation and design of switchboard wiring. A more or less common cause of trouble of the nature under consideration is operating polyphase turbo-generators (having solid core rotors) with the current per phase unbalanced, and the extent of the

damage to the rotor as well as the time in which the damage occurs varies with the amount of unbalancing.

By the use of a magnifying glass ridges can be seen in the up-turned end of the wedge, where it rubbed the stator laminations. Had operation continued with the wedge rubbing on the stator iron, and the rotor traveling at 3600 rpm, a serious wreck would unquestionably have occurred. The direct cause of the unbalancing, or more probable single phasing, has not yet been discovered.

In general the phase currents of polyphase machines with solid core rotors should not be permitted to become unbalanced in excess of approximately 10%. Naturally some machines, due to design, will operate satisfactorily and safely with a much greater unbalance of phase current, but the 10% rule mentioned above should in general be followed in all cases.

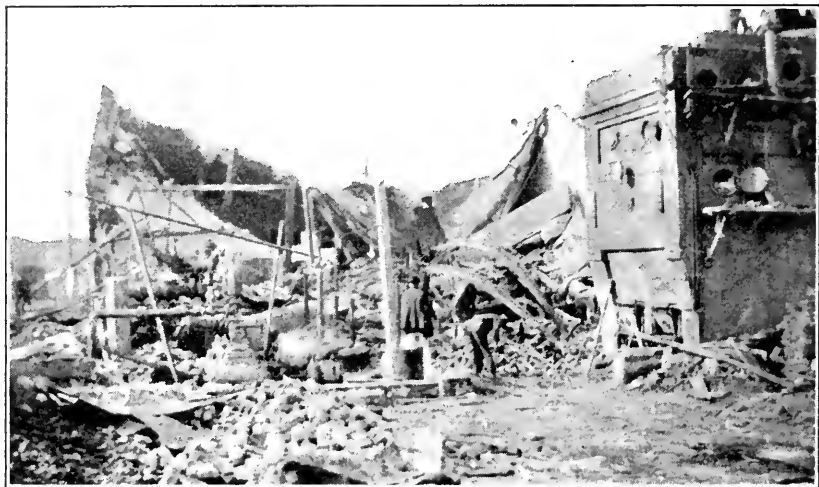
Figure 1

CORROSION that had taken place unobserved behind the masonry in which the blind head of a mud drum was buried caused the explosion of a water tube boiler at a municipal light and pumping plant on the night of April 5. Three men were killed

and three were injured. The fireman, his brother, and another workman were the ones who lost their lives; the injured were unemployed men who were in the boiler room in search of work.

The old style bumped head generally used in water tube boilers until a few years ago has a sharp turn at the flange that renders it particularly susceptible to corrosion because of the stresses set up by the flanging process and those caused by "breathing" action. When such heads are buried in brickwork, an accumulation of soot and ash will oftentimes pack between the head and the masonry. When this soot becomes moist, its sulphur dioxide content will form sulphurous acid, a substance that is very corrosive to steel.

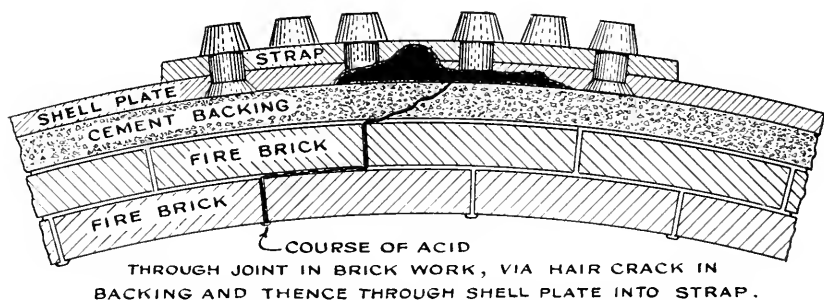
Figure 5

A section of a corroded butt strap is shown in Figure 4. The strap was of material $1 \frac{3}{16}$ " in thickness but reduced to $\frac{1}{4}$ " where a break in the lining had permitted the acid to reach the shell. The shell plate

was similarly grooved, and corroded to a less extent over a considerable area as indicated by the sketch in Figure 5.

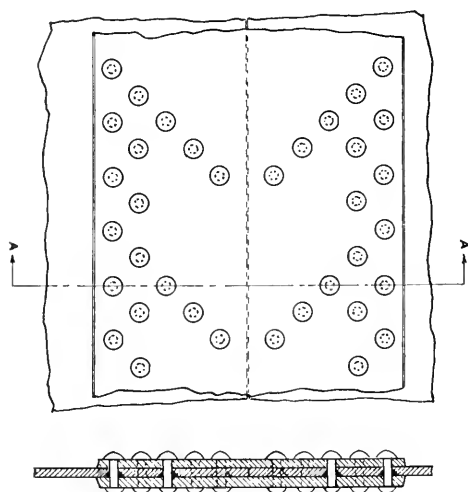
Figure 7

The reconstructed seam used more frequently in cases where this Company's investigation revealed the necessity for repairs is wider than the old seam and includes two additional rows of rivets on each side of the joint. As there is an inside and an outside butt-strap, rivets are in double shear so that it is possible to use a smaller rivet and thus produce a stronger joint. Use of the wider butt-strap has the additional advantage in each case of placing the additional rivet hole in a section of the shell plate where the metal has not been weakened either by corrosion or by stresses caused by the eccentric loading of the old seam.

through the shell plates are disregarded except to the extent necessary to use them to hold the butt-straps and plates firmly together near the center of the joint. The number of those rivet holes used does not exceed 30% or 35%, as shown in the illustration of the reconstructed joint, Figure 7.

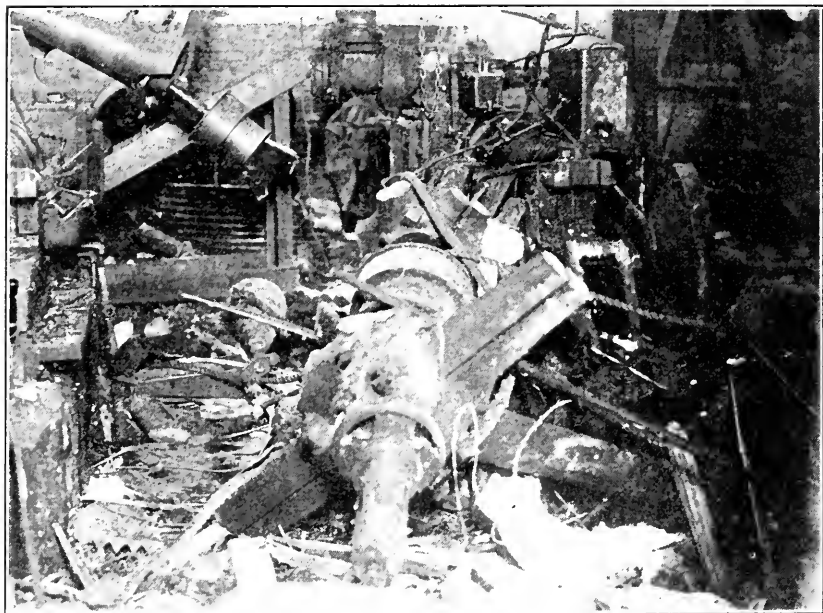
THE accompanying illustration is a picture of the wreckage of a paper making machine engine after overspeed exploded both the balance wheel and the rope wheel. The engine shaft was ripped out of the bearings and, with the exception of the cylinders, the machine was completely demolished. Flying parts damaged the building, other machinery and stock in process.

An investigation after the accident led to the conclusion that the trouble started by breaking of the belt between the two cone pulleys. This threw the engine out of control of the governor and allowed it to

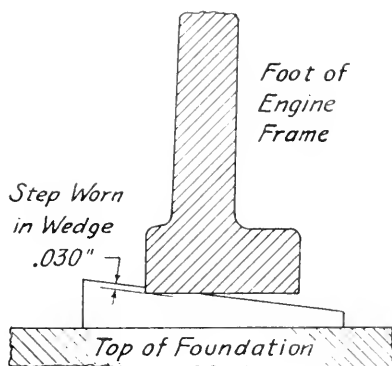
Figure 2.

shown in Fig. 2. In a recent case where the frame neck had cracked the wedge which was pulled from under the frame at "A" had a step worn in it of .030". This, of course, was the amount that the engine frame had sagged at that point. The vertical movement of the frame must have been a considerable proportion of this.

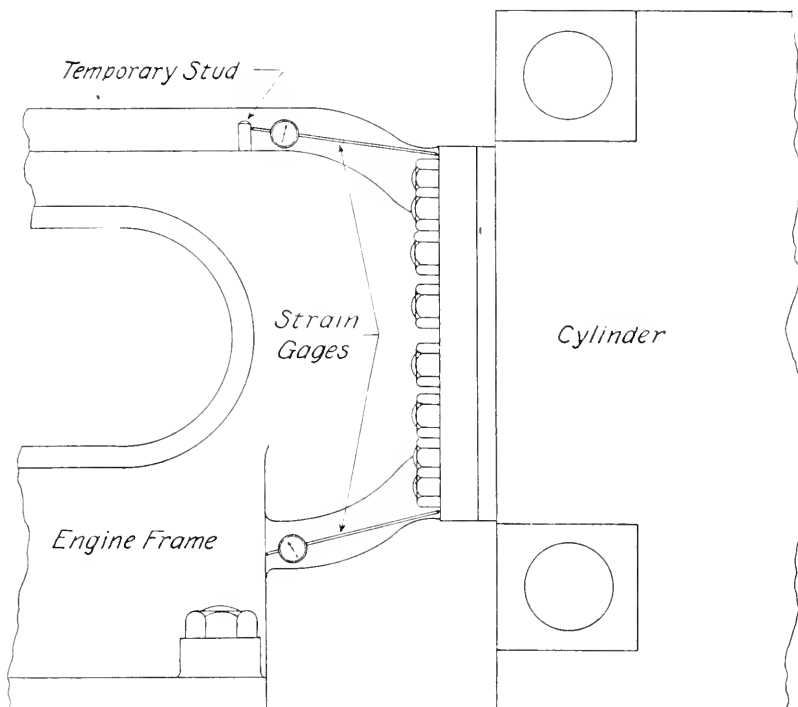
Fig. 3. Showing Application of Strain Gage.

bending stress in the frame neck due to sagging of the frame can be detected. This is by applying to the frame neck a simple strain gage such as is used by this Company's inspectors. The application of this strain gage is shown in Fig. 3. So long as the readings of the dial micrometer are reasonably alike at the top and the bottom of the frame while the engine is running under load there will be no trouble from cracking of the frame neck, as this indicates that there is no bending action at that point.

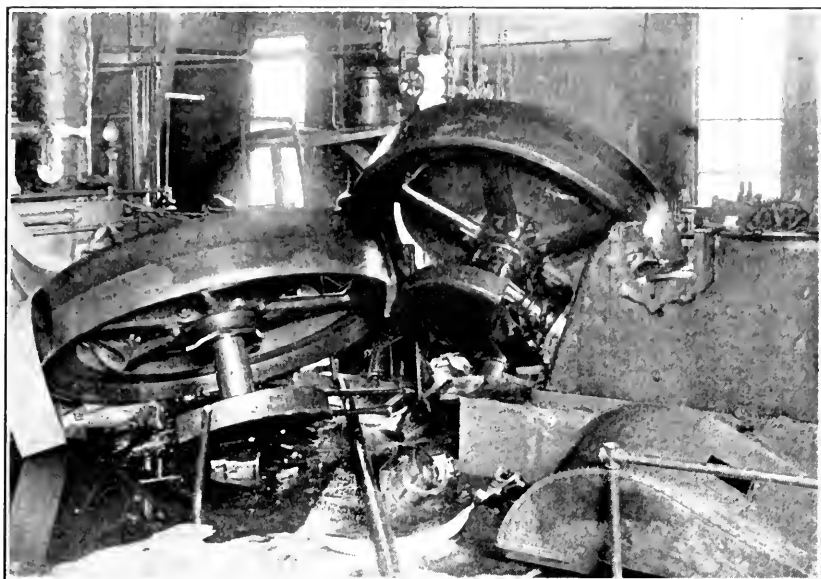
PAPER mills seem to have been let in for somewhat more than their just share of recent flywheel explosions. Since the appearance of the last issue of THE LOCOMOTIVE, in which one such accident was described, two other paper mills have been visited by the same sort of catastrophe. One of the accidents cost a man his life; both caused heavy property damage.

The accident at one plant occurred less than ten minutes before the beater engine was to have been shut down for the week-end, during which time the main belt was to have been shortened so as to eliminate a noticeable amount of slipping. From all indications the accident was caused by the breaking of this belt, but as the only man near the engine at the time was killed the exact sequence of events immediately prior to the accident is not definitely known. One large section of the 12-foot wheel was driven through the roof and landed on the ground almost 400 feet away. The building was badly damaged and, with the exception of the cylinder casting, the engine was a complete wreck. Property loss was more than \$15,000.

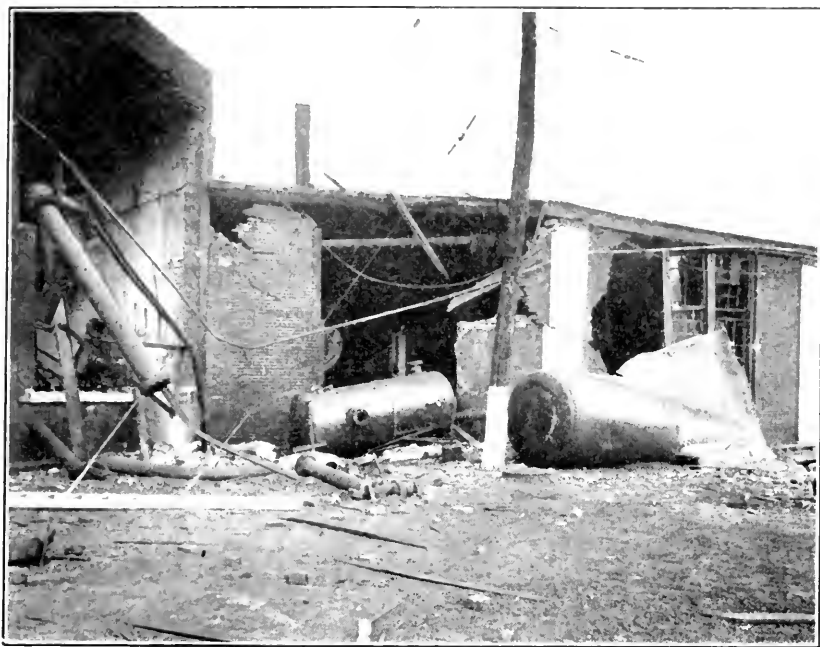
ACCIDENTAL ignition of lubricating oil vapor in a large air receiver at a railroad yard caused an explosion a few weeks ago that resulted in heavy property damage and injury of six persons. The tank was 66" in diameter and 17' 7" long. It was of lap riveted construction and was mounted vertically outside the engine house. The explosion blew off the top head and unwrapped the upper course by tearing through the solid plate. Had the tank been inside the building the damage would undoubtedly have been much more severe, but even as it was a brick wall was hurled down and windows in houses a third of a mile away were shattered.

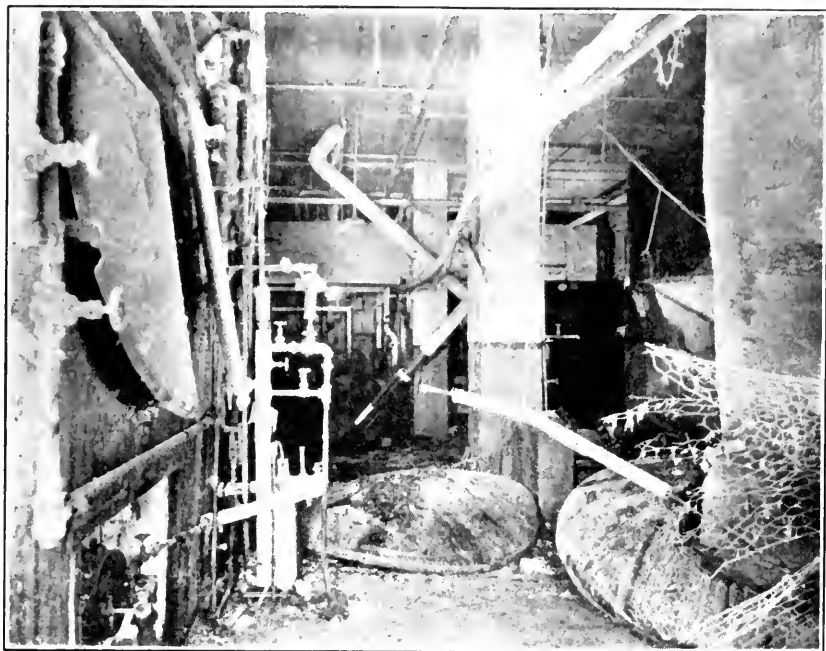
Figure 2.

A majority of hydro-pneumatic systems are motor-driven units with some sort of an electrical relay which starts and stops the motor automatically at certain pressure limits. Figure 2 shows the damage caused recently by the explosion of a tank in such a system at a hotel. This system had no safety valve, the relay being depended on to prevent over-pressure by shutting down the pump. However, the relay failed to work and the resultant property damage was close to \$5,000. Figure 1 is a view of another such tank that failed by blowing out the head and tearing along the longitudinal seam.

Automatic controls for the pump should not be depended on as the only protection against over-pressure. In all cases they should be augmented by a relief valve installed either on the tank or on a pipe freely communicating to the tank. Where the relief valve is on some

part of the piping system, it is important to see that no check valve or stop valve is installed between it and the tank.

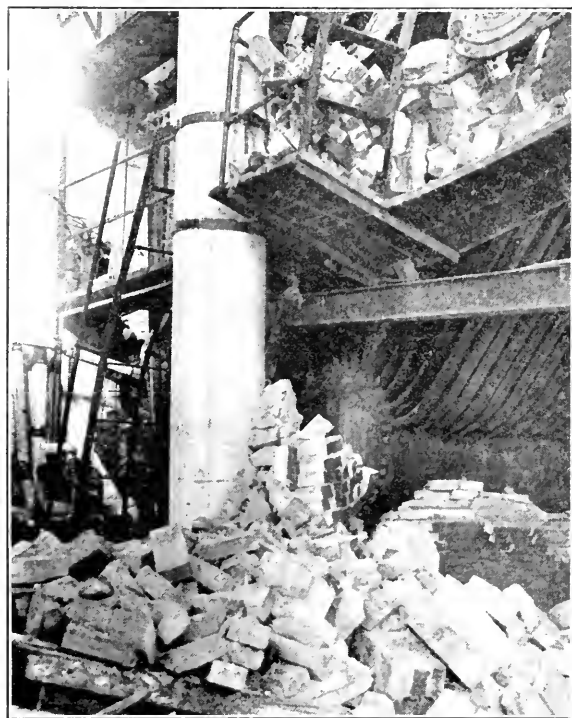
The steel columns supporting the boiler and the 18" steel girders between these columns were so badly bent and twisted that an entire new supporting structure had to be installed. Deflection of the support caused the boiler to drop about three inches, breaking the blow-off pipe, the safety valve "Y", and several smaller pipe connections. A companion boiler also was badly damaged, as the explosion

ripped open the breeching and carried away the safety valve. It took thirty-six hours to place the spare boiler in operating condition. Figure 1 shows some of the property damage, which was estimated at \$6,000.

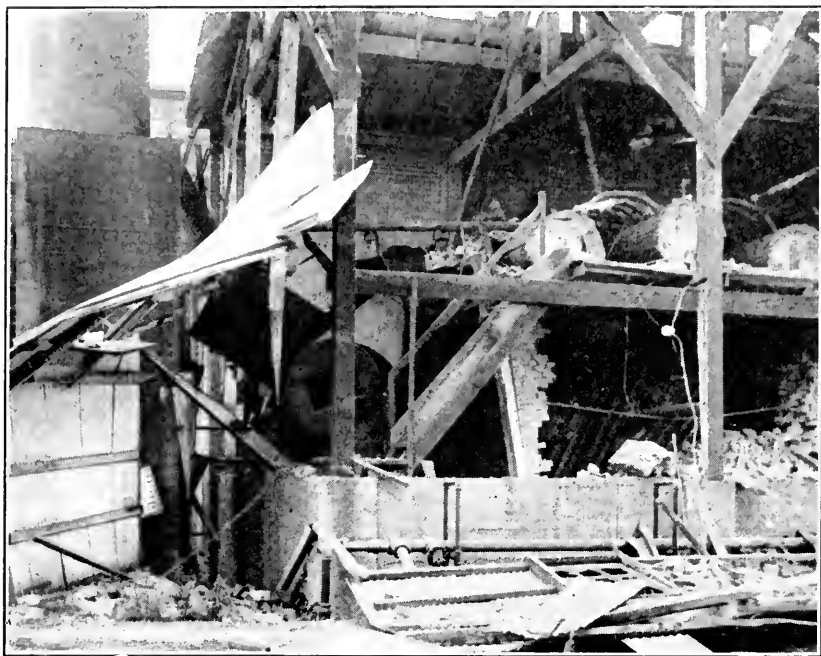
Figure 2

July when the engineer of a paper products plant in Los Angeles lost his life. As in the case just described, the breeching was destroyed and the brickwork of the setting knocked down. Caught under the brick wall as it fell, the engineer was crushed. As is indicated by the illustration shown in Figure 2, the property damage was considerable. An estimate placed the plant's financial loss at \$10,000.

It was thought that perhaps the accident was caused by the engineer permitting the gas pilot to flow too long before igniting it, but as the victim was alone in the boiler room at the time this supposition could not be checked. It seems more probable, however, that there may have been a leak in the gas or oil lines that resulted in the furnace filling up with combustible vapor, as in the case previously described.
